Fluorescence with ARTISTA®?

“ARTISTA® contains no tin layer!”

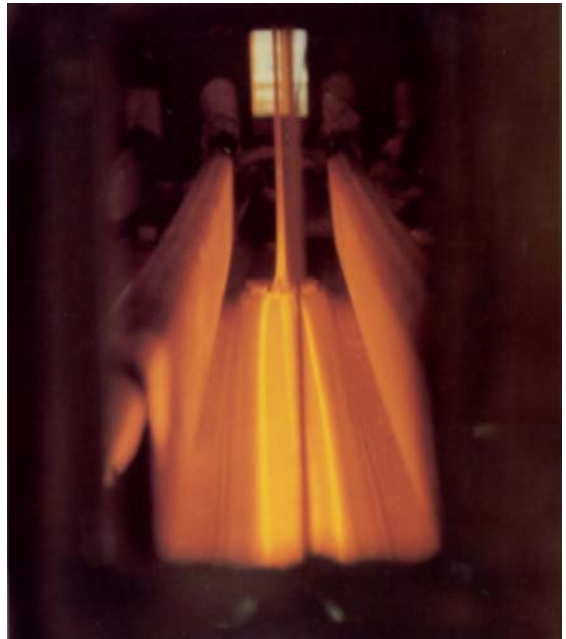
This photograph shows a ceramic nozzle from which the viscous glass is being drawn upwards.

Viscous glass that extrudes from a ceramic nozzle is gradually drawn up perpendicularly through a so-called drawing machine. Before it actually comes into contact with the rollers inside the drawing machine for the first time, the surface of the glass cools off and solidifies to the extent that it can no longer experience imprints or scratches.

To prevent slight scratches from being caused by the rollers in the drawing machine, a small dose of sulfur dioxide is applied to the still viscous glass near the ceramic nozzle. (See photo).
